# RFS7000 Series RF Switch

## Troubleshooting Guide

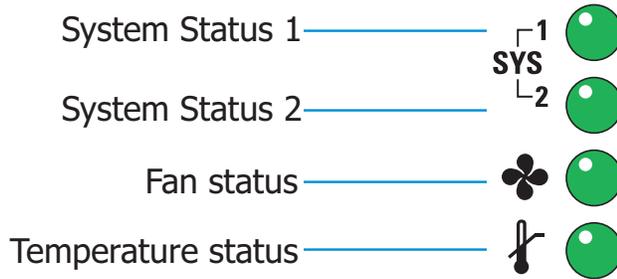
The RFS7010 RF Switch has four vertically-stacked LEDs on its front panel. Each of the switch's Gigabit Ethernet ports have two status LEDs. These LEDs display two colors (green & amber), and three lit states (solid, blinking, and off). The following tables decode the combinations of LED colors and states for the System Status LEDs and the Gigabit Ethernet LEDs.

## 2.1 System Status LEDs

System Status 1 LED	System Status 2 LED	Event
Off	Off	Power off
Green Blinking	Green Blinking	Power On Self Test (POST) running
Green Solid	Green Blinking	POST succeeded (Operating System Loading)
Green Solid	Off	POST succeeded (Normal Operation)
Amber Blinking	Off	POST Failure
Alternating Green Blinking & Amber Blinking	Alternating Green Blinking & Amber Blinking	Boot Up Error: Device has an invalid checksum

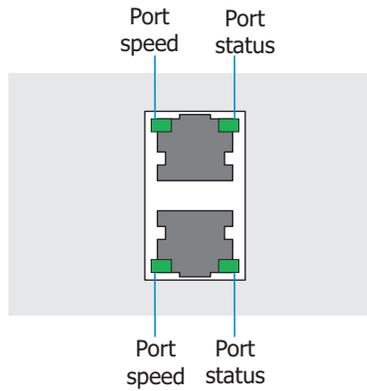
## 2.4 RJ-45 Gigabit Ethernet LEDs

Port Speed LED	Event
Off	10 Mbps
Green Solid	100 Mbps
Green Blinking	1000 Mbps
Amber Blinking	Port Fault

Port Status LED	Event
Off	No Link or Administratively shut down
Green Solid	Link present
Green Blinking	Activity: Transmit and Receive
Amber Blinking	Link Fault

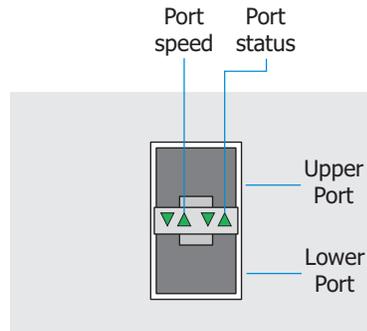
## 2.5 SFP Gigabit Ethernet LEDs

Port Speed LED	Event
Green Blinking	1000 Mbps
Amber Blinking	Module or Tx/Rx Fault Loss

Port Status LED	Event
Off	No Link or Administratively shut down
Green Solid	Link present / Operational
Amber Blinking	Module or Tx/Rx Fault Loss

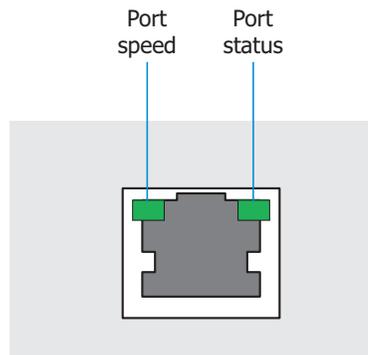
## 2.6 Out of Band Management Port LEDs

Port Speed LED	Event
Off	10 Mbps
Green Solid	100 Mbps
Amber Blinking	Port Fault
